Manhole Inspection Summary

Manhole # S25EE1043MH

Insp Date: 1/23/07 11:05 AM

Location Address: **1110 CROWTHER ST**

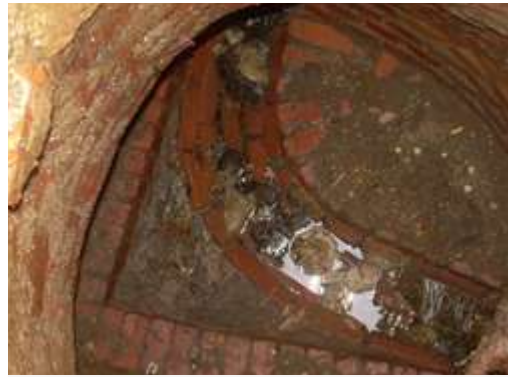
Top View

Evidence of surcharge - Bench debris.
Channel debris.

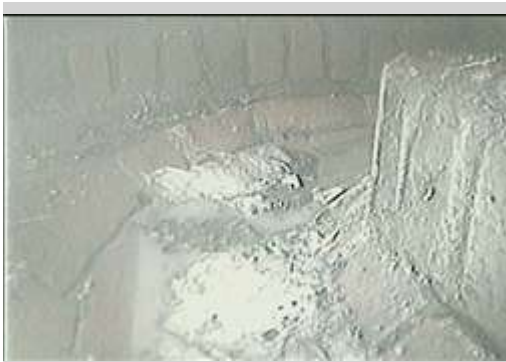
Defect

Channel deterioration and debris.

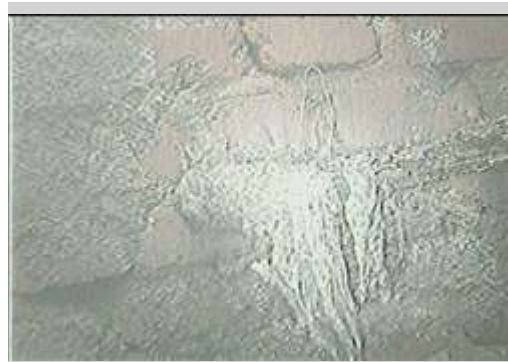
Defect

Evidence of surcharge.

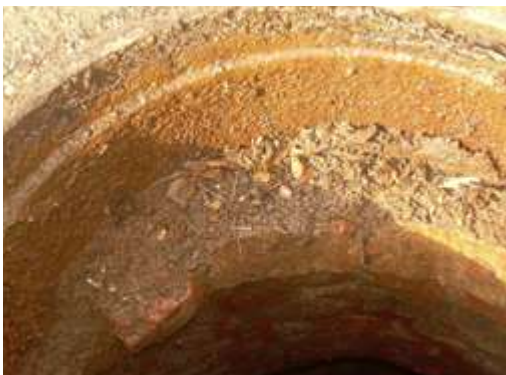
Defect

☒ **Leaks**

Condition: ☐ Sound ☐ Cracked ☐ Root Intrusion ☒ **Loose Brick** ☒ **Deteriorated**

Infiltration: ☐ None ☒ **Joint** ☐ Cracks ☒ **Mortar** ☐ Roots ☐ Wall

Frame leaks. Frame offset. Adjustment
deterioration, loose brick and infiltration.

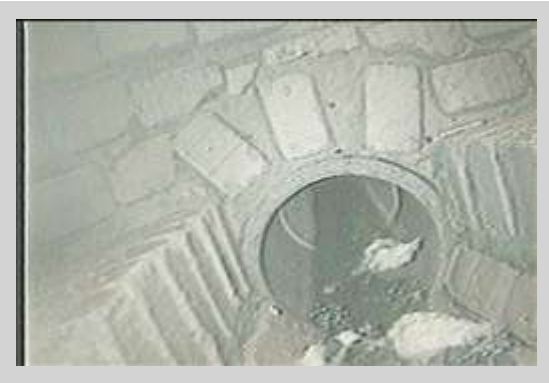
8 in. Circular Gravity Sewer Pipe Out @ 12 O'Clock

Deposits: ☐ None ☒ **Mud** ☐ Sludge ☒ **Debris** ☐ Grease

Silt Depth: **0** (in.) Deposits Extent: **Light**

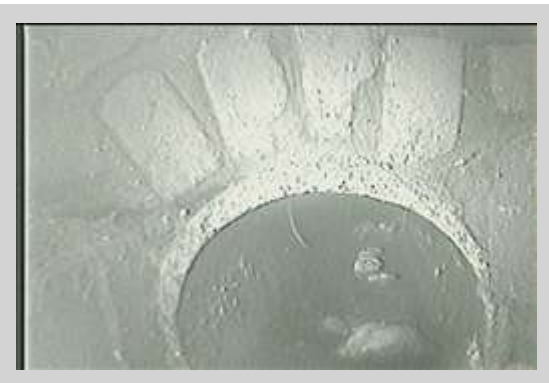
8 in. Circular Gravity Sewer Pipe In @ 4 O'Clock

Deposits: ☐ None ☒ **Mud** ☐ Sludge ☒ **Debris** ☐ Grease

Silt Depth: **0** (in.) Deposits Extent: **Light**
